2nd International Conference on
**Historic Earthquake-Resistant Timber
Frames in the Mediterranean Area**

Lisbon • LNEC • December 2-4, 2015

Book of Abstracts

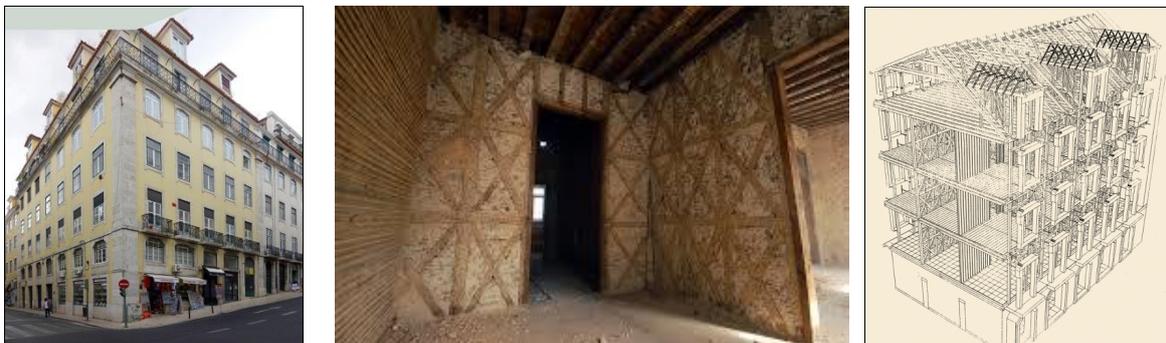
Figure 1 – A combined masonry and timber structural traditional system used Lisbon, Portugal

The inclusion of timber structural elements in masonry buildings to increase their seismic resilience has a long tradition in Mediterranean earthquake prone regions as the result of an existing local seismic culture. Examples of this strengthening construction practice can be found in Portugal, Greece and Italy and were generally enforced by local authorities after the occurrence of destructive historical earthquakes. Two emblematic examples are the structural dual system used in the island of Lefkadas in Greece and the “Pombalino” buildings of downtown Lisbon [1, 2] (Fig. 1).

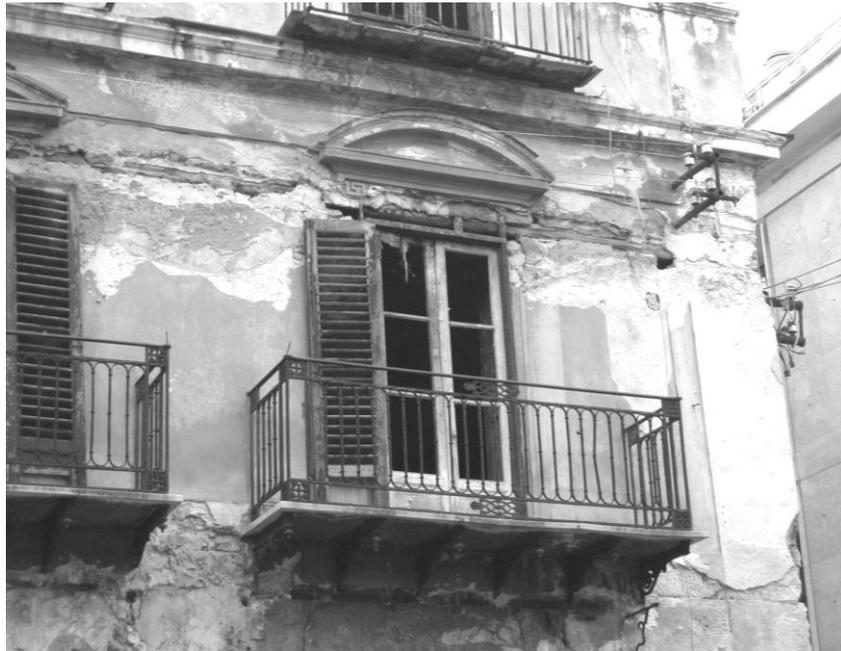
Wooden systems for ceiling support and lintel of openings and lighten partition wall.

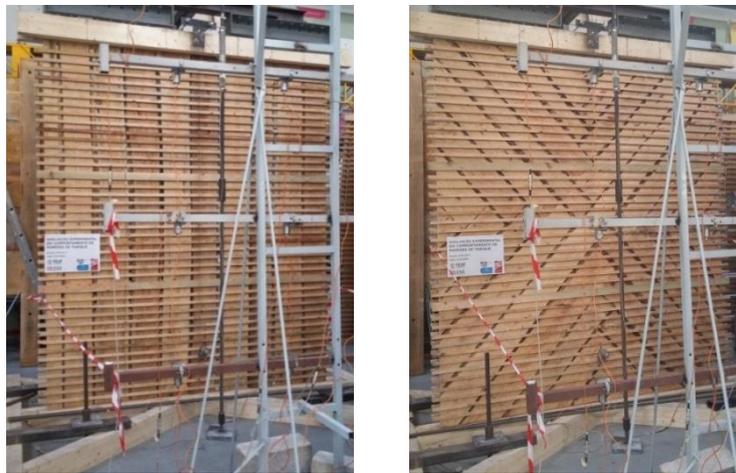
Figure 1 – TWs specimens

TWs are commonly used as interior partition walls and are often considered as non-structural and low resisting elements, having no ability to contribute to improve the overall performance of the buildings. These walls, which are quite slender (height to thickness ratio usually greater than 20), are mainly made of vertical timber boards juxtaposed with a gap of around 2cm, that may be framed and/or diagonally crossed (cutting or not the vertical boards) by thicker planks. This timber vertical structure is usually covered by a series of horizontal wooden laths nailed on the boards that improve the adhesion of the finishing layer of lime mortar or earth based render. These are the so called simple TWs, in opposition to the double TWs, which are made of two layers of boards: a layer of diagonal boards overlaid to the layer of vertical boards (see Fig. 1).

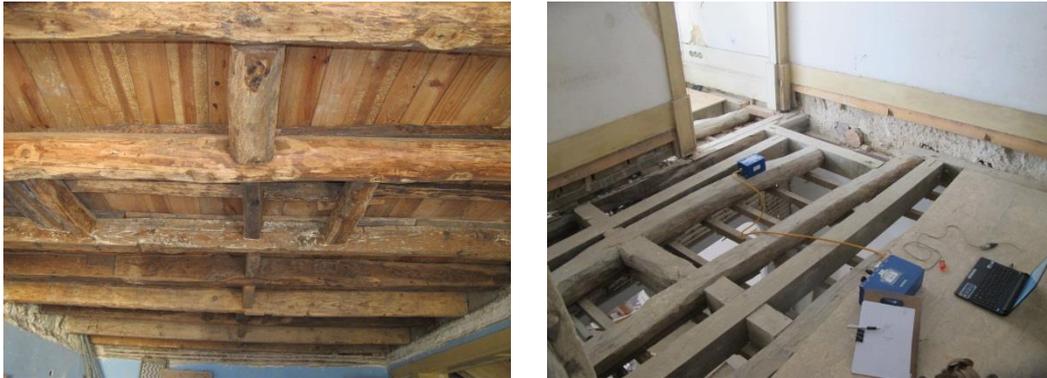
Figure 1 – Timber floors: a) timber beams and wooden floorboards; b) performed tests.

buildings made of stone masonry walls at the contour and timber walls at the inside (although exceptions exist for both type of walls – stone masonry walls outside and timber walls inside) and timber floors and roofs. The structural system of the floors is typically made of timber beams with a span of not more than 5m and struts in between. The beams are materialized by tree trunks, either full, partially cut, or fully cut into rectangular section elements. To guarantee the horizontality of the floor, wood billets are placed between the beams and the floorboards. The boards are nailed to the beams, as well as the ceilings of the lower floors (a structure made of wooden thin laths placed perpendicularly to the beams supporting a wood and plaster covering). Fig. 1 shows some of the elements that constitute these timber floors and illustrates tests performed on the floors.

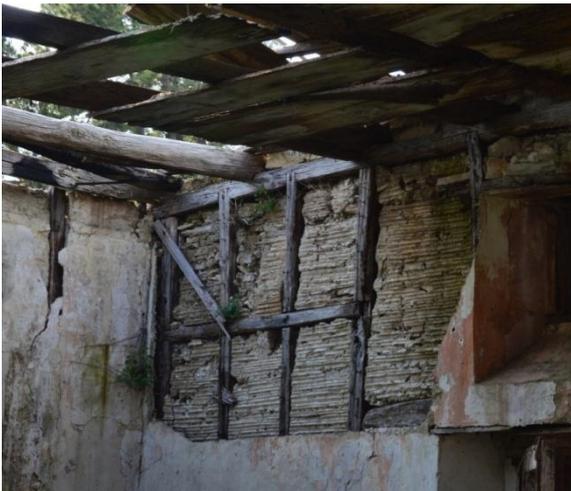
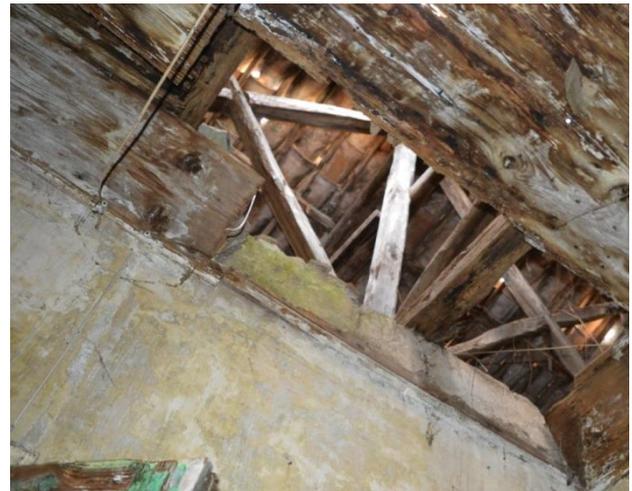
Fig. Timber frame emphasizing alternated notches at the ring level (on the left) roof Saint Andrew crosses (on the right)

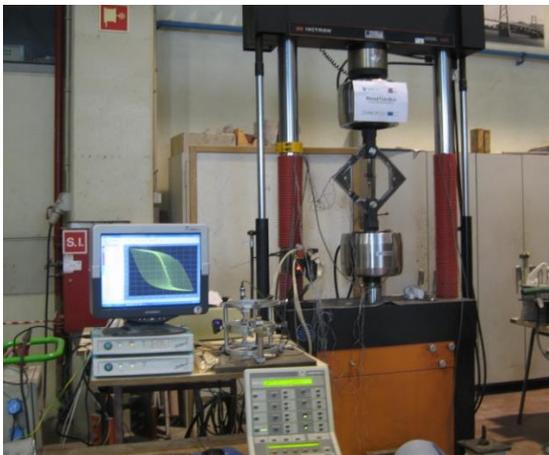
Figure 1 – Experimental setup for testing the Hysteretic Dampers.

The experimental diagrams of the prototypes of the Dissipation Panels show good capacity to dissipate energy, both in tension and in compression. The energy dissipated in each cycle corresponds to the area enclosed by the load-displacement curve.

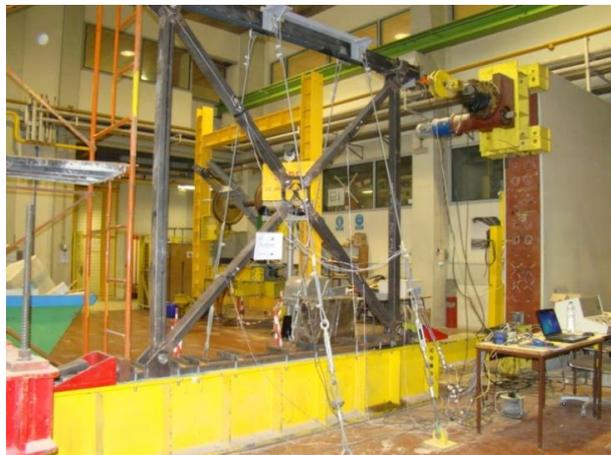
Figure 2 – Experimental setup for testing the Dissipation Panels.

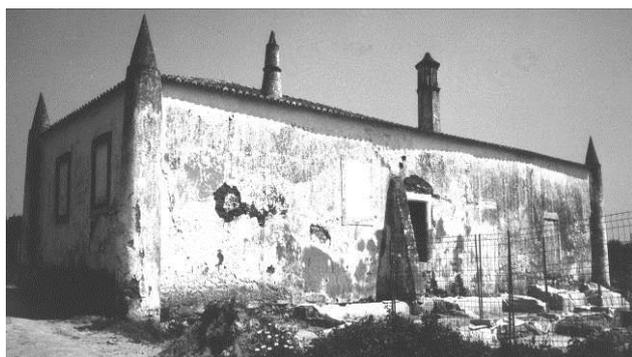
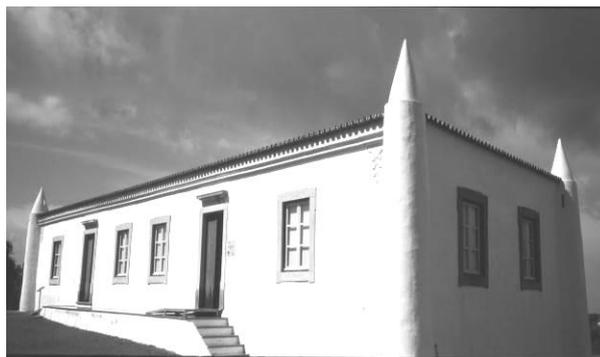
Fig. 1 – The Milreu archaeological site – the XVIth. Century Rural House.

a. Existing building (1970's)

b. Rehabilitated building (2000's).

The building was “rehabilitated” in the 1970’s with a heavy precast prestressed concrete roof cover, with hollow ceramic infill blocks and a cast “in-situ” concrete top layer. During some decades, small displacements were observed in the masonry walls, followed by increasing cracks, which prompted the Portuguese Heritage Agency to initiate an intervention. Several major problems had to be solved, in particular, the structural concrete roof system removal, to bring this building to the adequate conditions to be visited by the public. The design proposal to reduce the equivalent seismic action at the roof level required the removal of the structural concrete roof slab, with an estimated total dead load (DL) of 120 tons. A new timber roof system made with maritime pine replaced the existing roof, decreasing the total DL more than 2/3 to 40 tons., see Fig. 3.

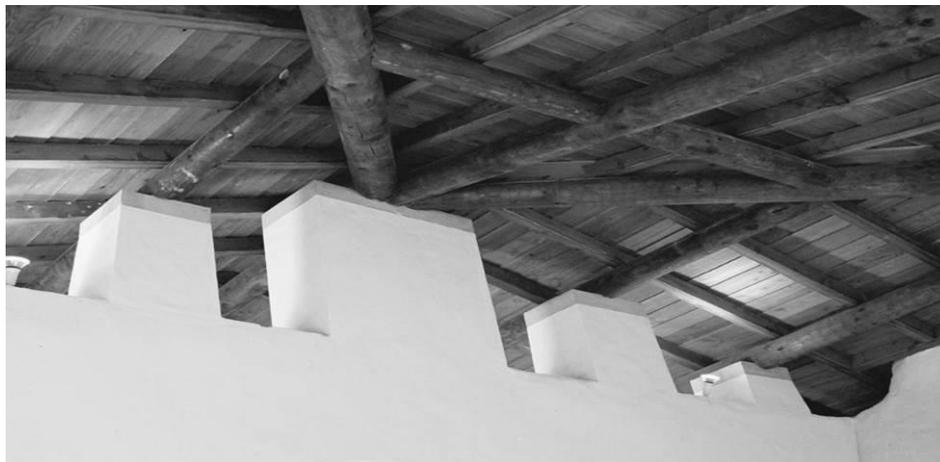
Fig. 3 – The timber roof structure with the short masonry pylons supports.

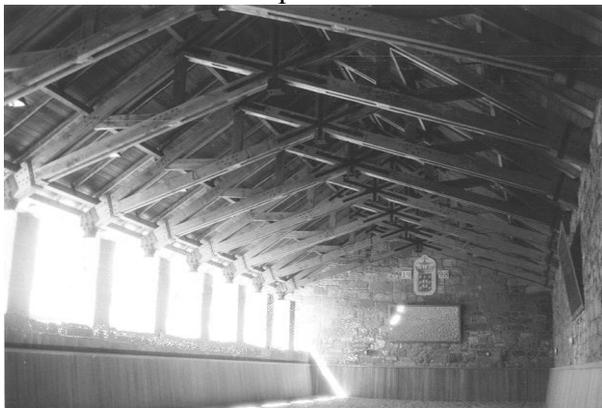
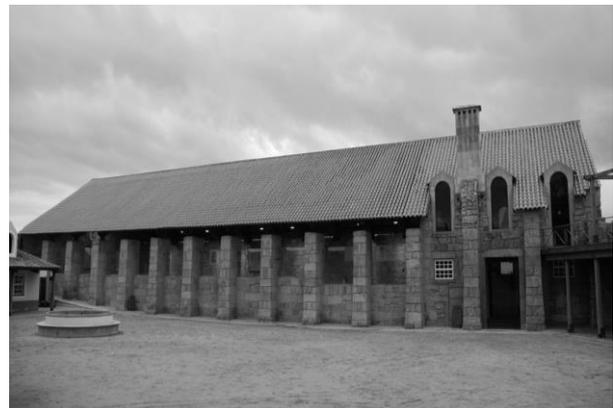
Fig. 3 – The Citadel of Almeida *manège* rehabilitation project.

a. South façade with “giant” columns.

b. Interior view towards west end wall.

This building rehabilitation process was one of the most successful projects, for the EU “Aldeias Históricas” (Landmark Villages) program (Phase I), sponsored by the Portuguese Heritage Office (IPPAR) due to the excellent craftsmanship and the use of structural timber. In this solution the structure is completely exposed to the public view and detailing plays a major role, see Fig. 3. Low maintenance and a simple technical assistance to the contractor’s team deserves to be mentioned.

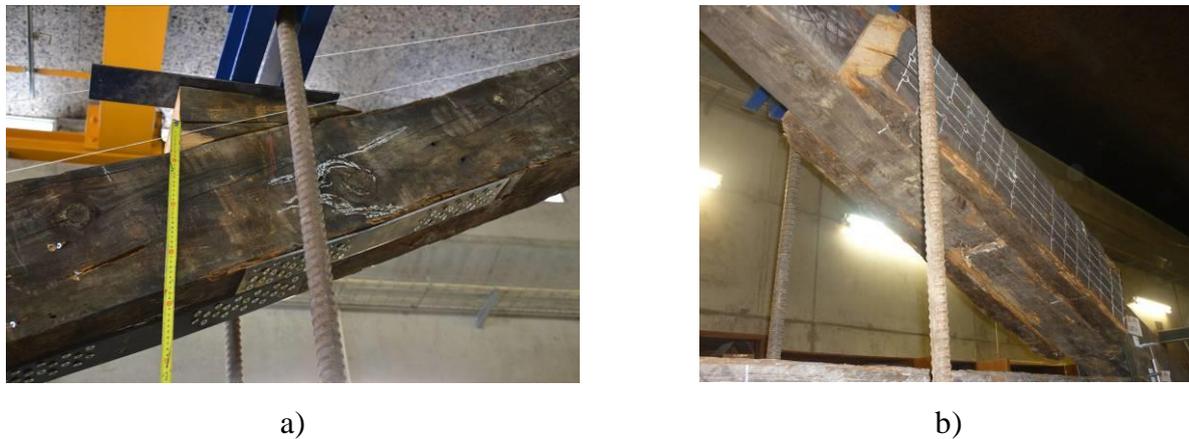
Fig. 2 – Strengthening techniques with screwed: a) metal plates b) timber elements.
